# Town of Chatham

## Columbia County, NY

**Ridgeline Identification Without Ranking - Draft 2**

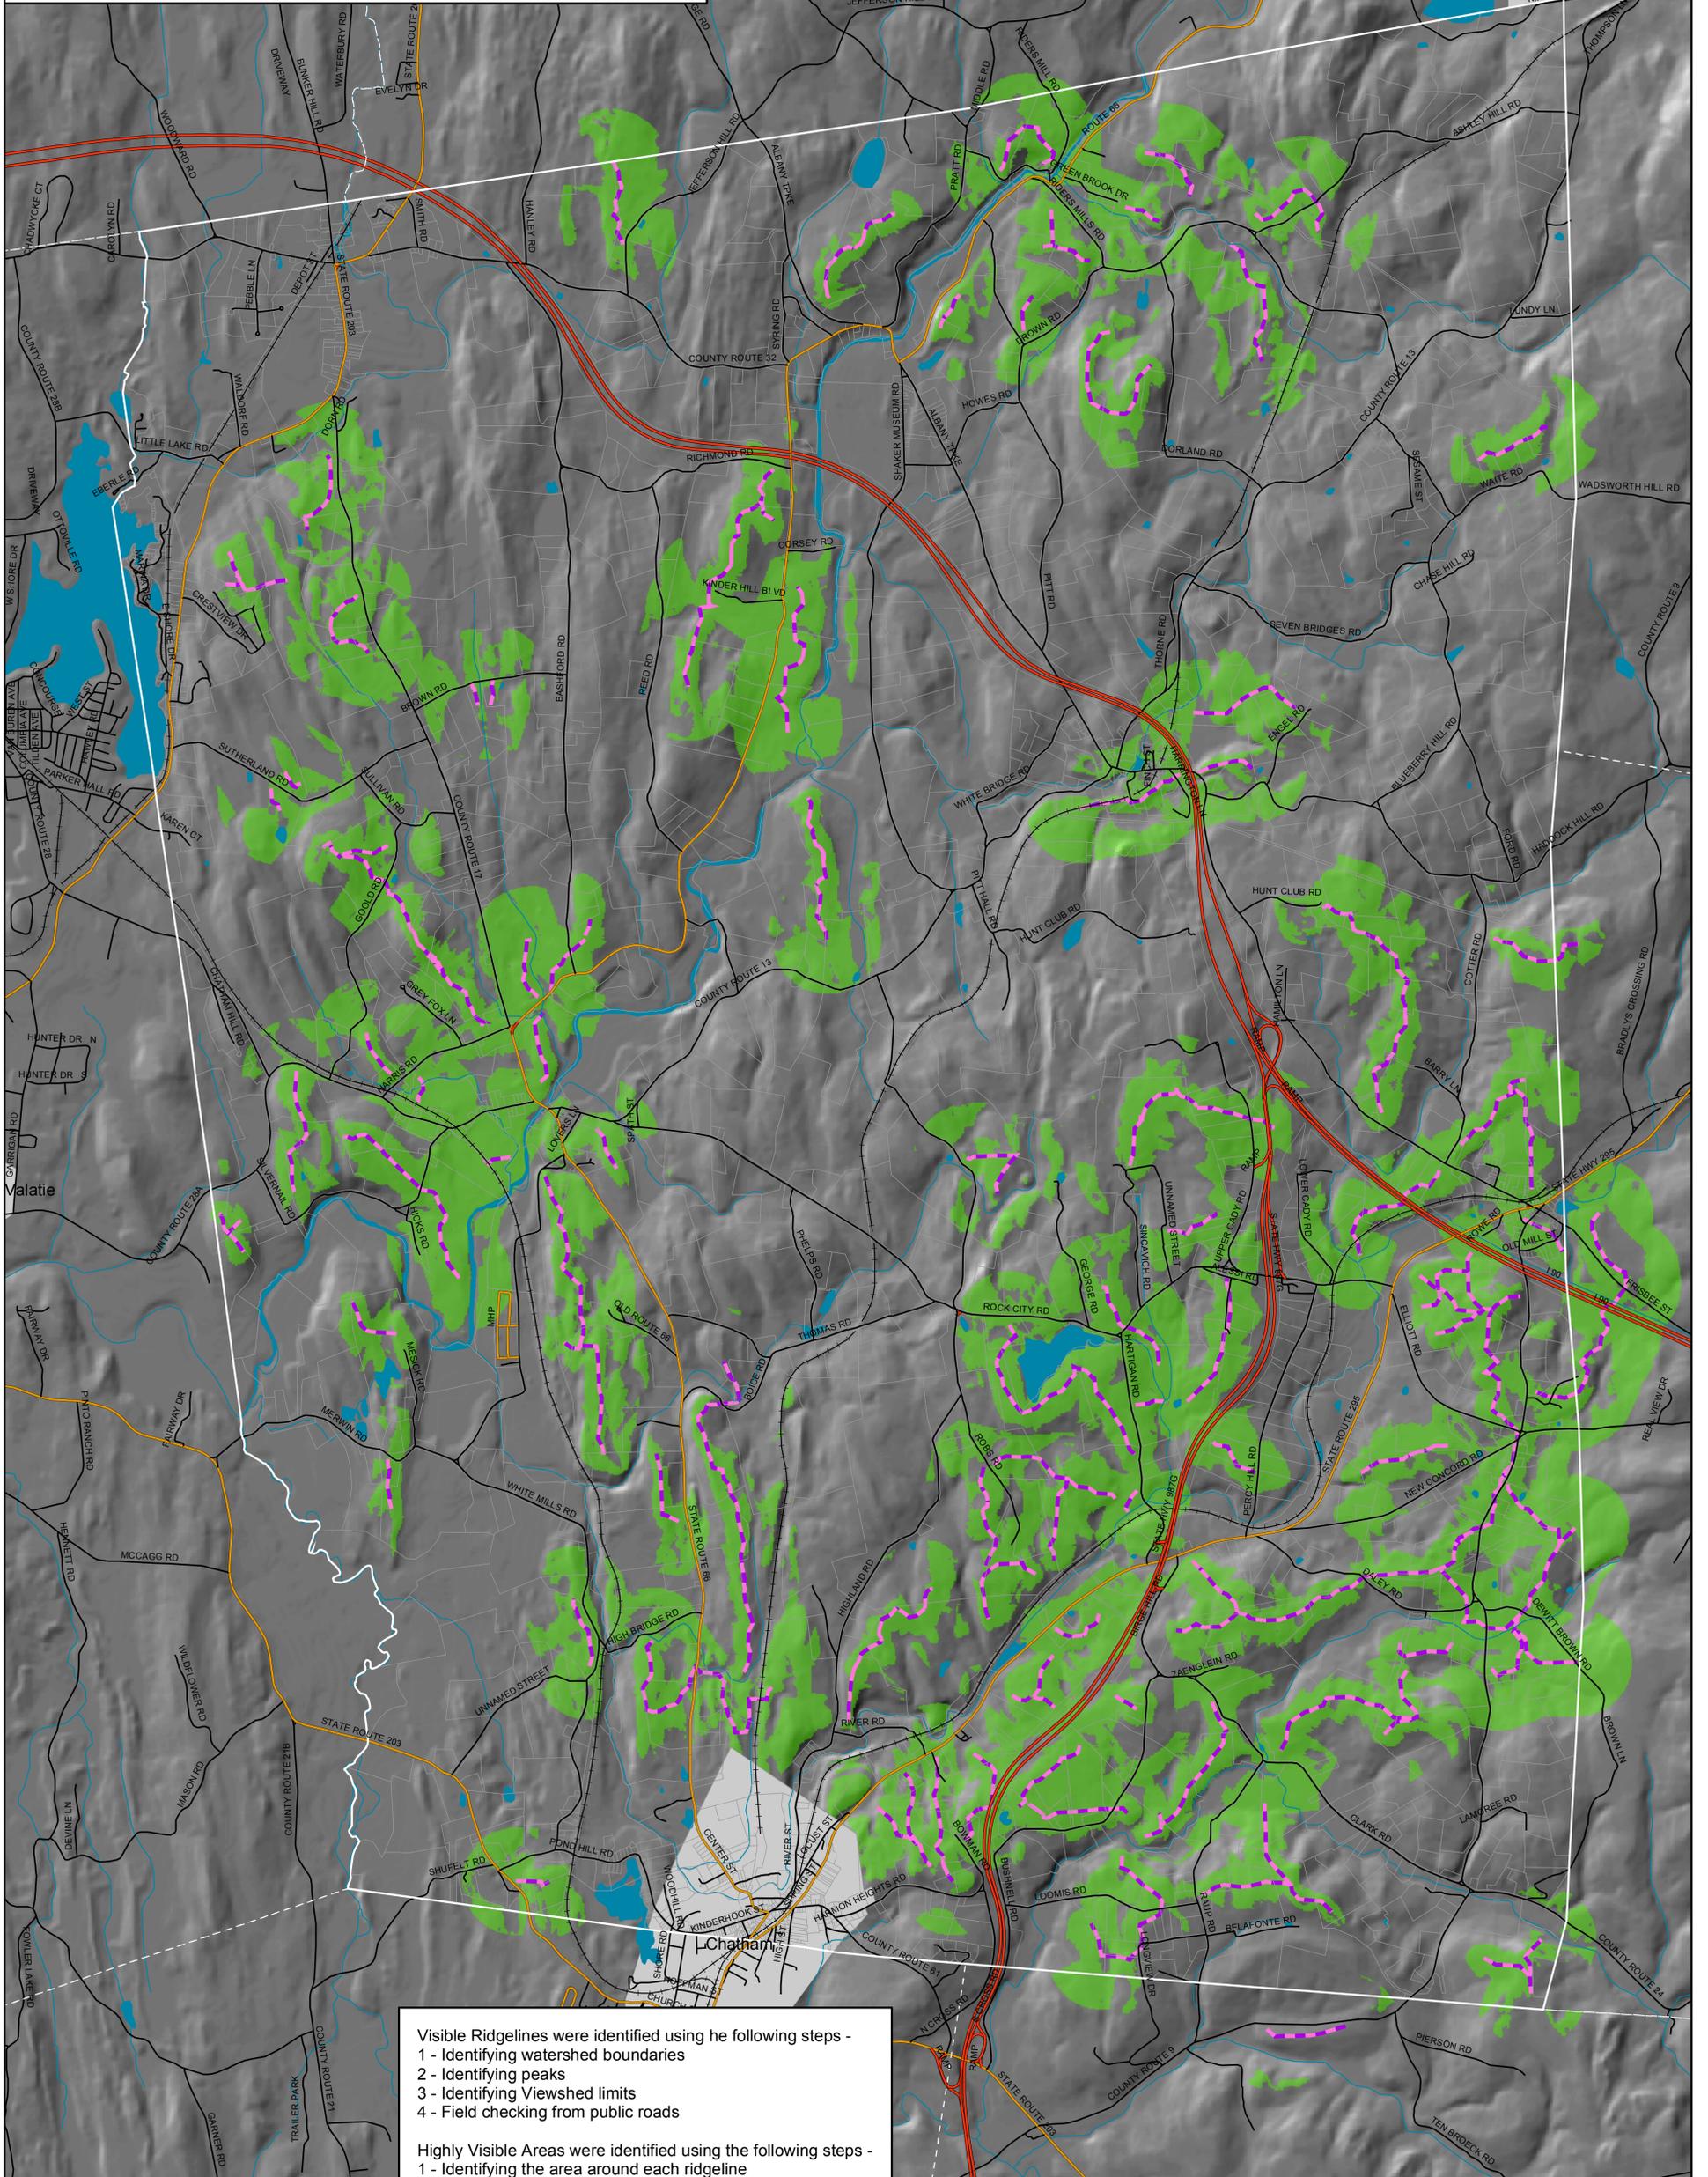
Visible Ridgelines were identified using the following steps -

- 1 - Identifying watershed boundaries
- 2 - Identifying peaks
- 3 - Identifying Viewshed limits
- 4 - Field checking from public roads

Highly Visible Areas were identified using the following steps -

- 1 - Identifying the area around each ridgeline within 40 feet in elevation (a 40' elevation buffer)
- 2 - Clipping the elevation buffer to within 1/4 mile of the ridgeline
- 3 - Further clipping the 1/4 mile buffer to the area identified as visible from a public road

--- Visible Ridgelines - v2  
 Highly Visible Areas - Not Ranked
